**Energy Utilization  
Management Bureau**

# **Quality Aspects of PV Program in the Philippines**

*ICRA/IEA Task 9 Regional Workshop  
Lane-Xang, Hotel Vientiane, Lao PDR  
April 7-9, 2005*

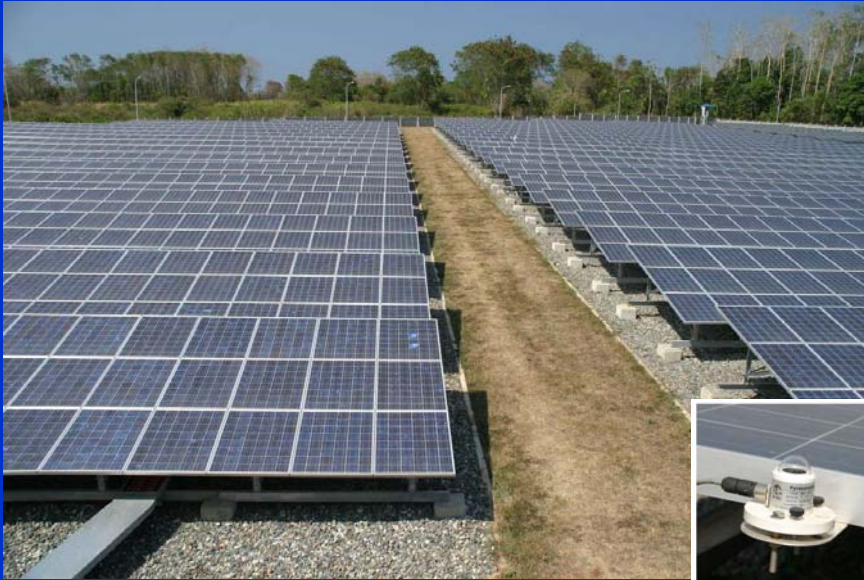
## Case 1. Cagayan de Oro Solar Power Plant

- *The system was designed and installed appropriately.*
- *Installed components are reliable.*
- *The layout of the PV array is very beautiful.*
- *According to CEPALCO, there was a trouble in the junction box and has been improved properly.*
- *The condition of the system operation is monitored continuously with a data monitoring system. The monitoring data showed an ideal operation index, when we visited the site.*

- *No technical problem was found in the system. Dust, however, accumulates on the array surface coming from the unpaved road beside the power plant.*

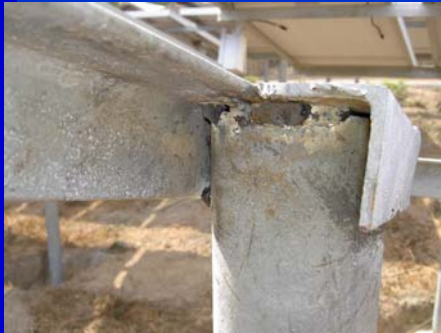
### Welding of Array Support

<Imperfect joint >

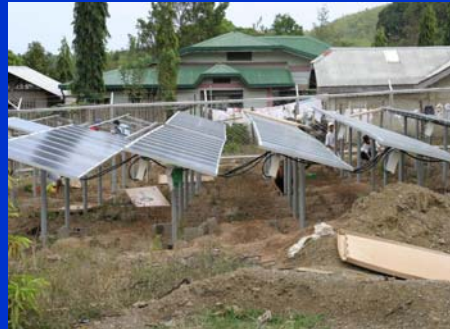
### Distorted & Curved PV array

<Poor installation >

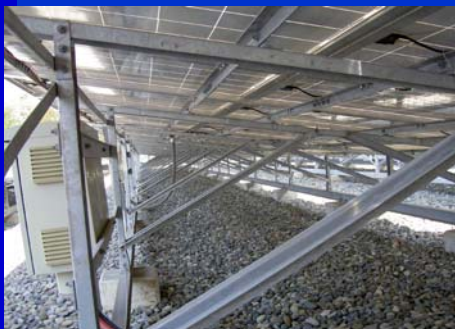
### Cagayan de Oro

<Recommended>

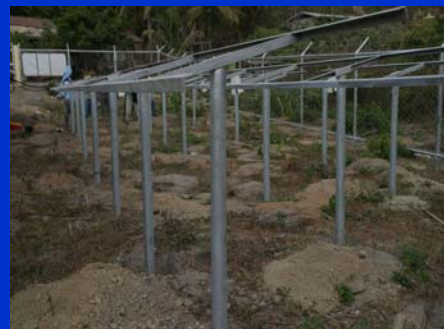
### El Nido

<Not recommended>

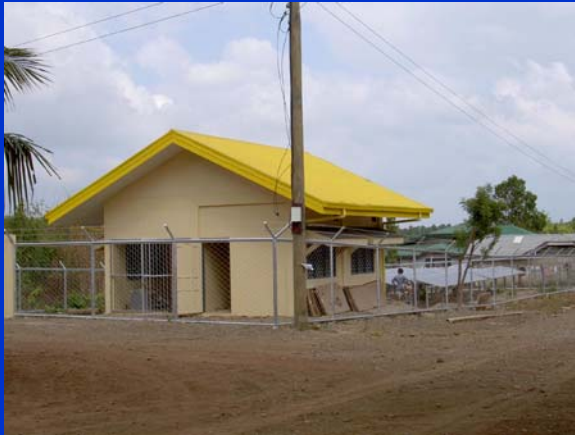
## Layout of the Solar Power Plant, El Nido Site

<Power house locates unsuitable position>

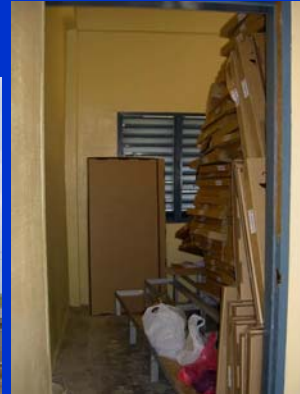
**Battery Room**

- *This system has a lot of problem due to poor system design.*
  - *Poor system design. ( Available supply power estimation, system balance between main system (PV) and the backup system(DG) etc. ).*
  - *Poor site layout design*
  - *Unsuitable design for battery room. (Storage battery generates combustible gas that is hydrogen . Battery room should always keep good ventilation)*

<Insufficient ventilation>

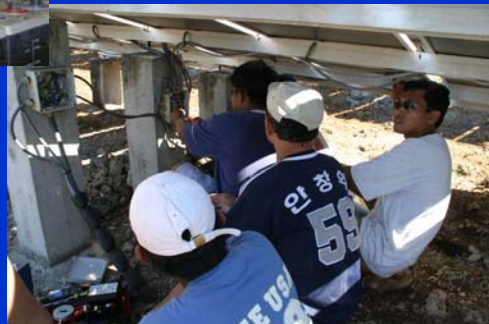
<At Pangan an site>

Corroded Terminal

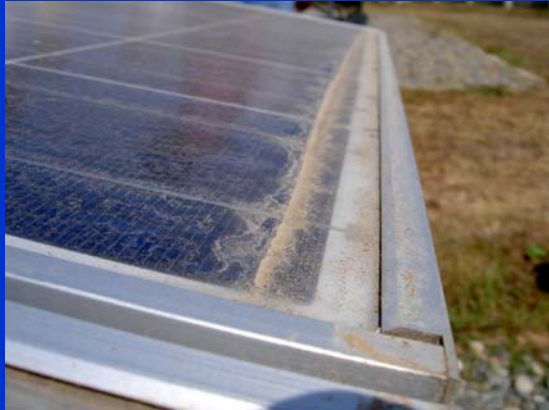
Dusty PV array

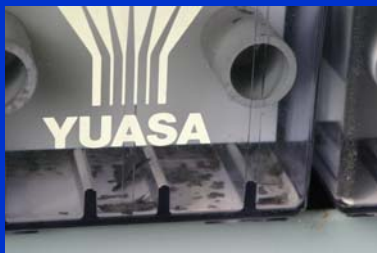
<Marshall Islands site>

Deposit in the bottom of battery

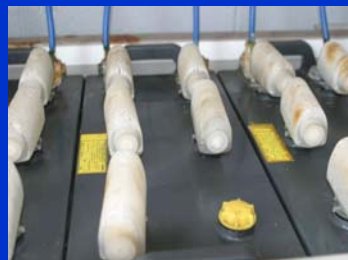
Well Maintained
