**Energy Utilization  
Management Bureau**

# **Quality Aspects of PV Program in the Philippines**

*ICRA/IEA Task 9 Regional Workshop  
Lane-Xang, Hotel Vientiane, Lao PDR  
April 7-9, 2005*

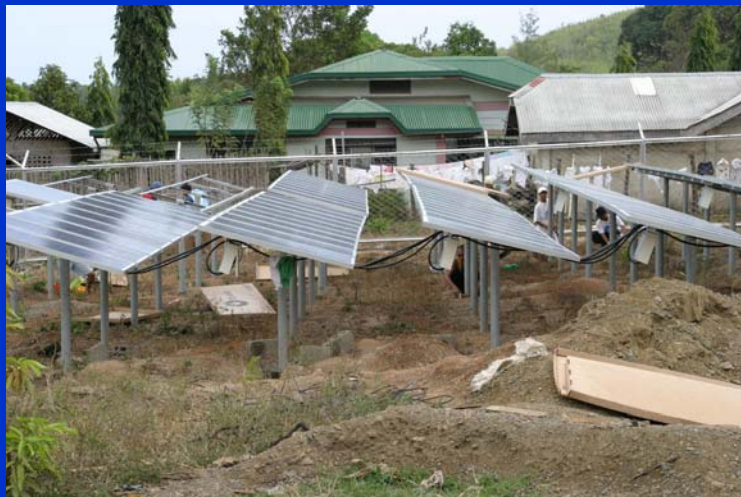
### Solar Power Plant (during construction)

- *The system is under construction as of 5 March, 2005 by local technicians. 50 households are connected to the system, 68 households will join later. Other households are not sure for connection. Total number of households is 200.*
- *Forty kilowatt hour (40kWh) electric power can be expected from the 20kW PV system without backup. The available power per household a day will be approximately 340Wh, if 118 households, which are already registered, are connected. If the power demand increase more, backup operation with DG will be required every day.*

- *This system has a lot of problem due to poor system design.*
  - *Poor system design. ( Available supply power estimation, system balance between main system (PV) and the backup system(DG) etc. ).*
  - *Poor site layout design*
  - *Unsuitable design for battery room. (Storage battery generates combustible gas that is hydrogen . Battery room should always keep good ventilation)*

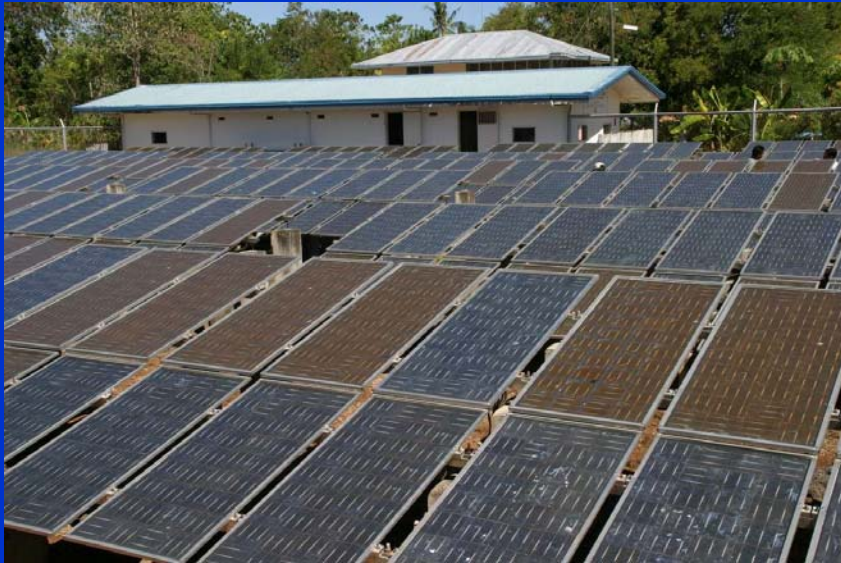
## Case 3. Pangan-an, Island Solar Power Plant

*Poor quality of the PV modules: Some module surface change to abnormal color  
Some module consist of tow types of PV cells, that is single crystal ell and poly-crystal one. The seal of module seems to be insufficient.  
Some cells of the modules have been damaged (cells were blown out).*

### Use of certified modules is strongly recommended.
